2023 RDV GATOR REPAIRS

Prepared by Jason Golka

October 2023

TABLE 1: DEFICIENCIES LIST AND CORRECTIONS

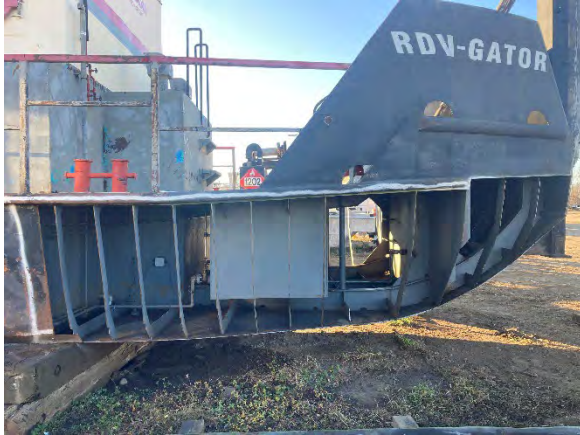
ITEM #3 Cropped Starboard Side

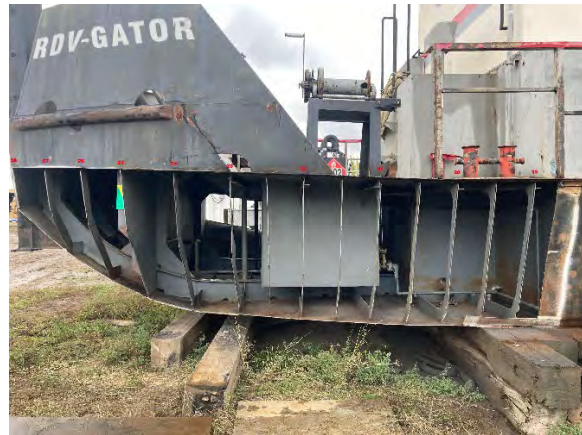
ITEM #3 Cropped Port Side

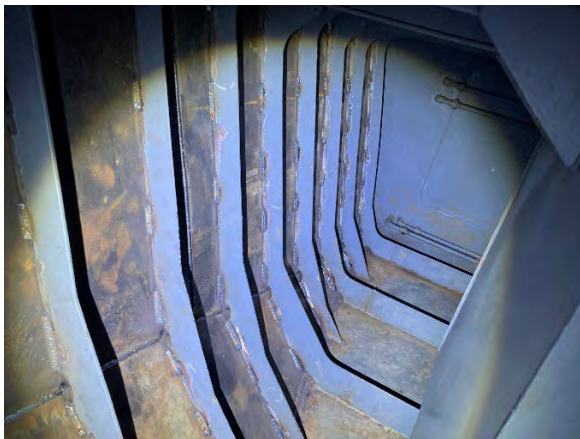
ITEM #3 Internal Starboard Renewed Stitching on Ribs

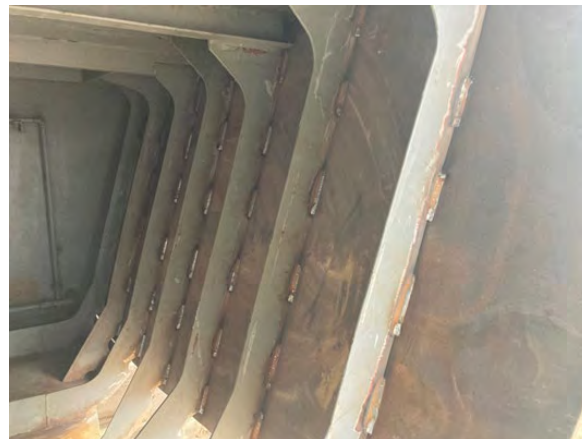
ITEM #3 Internal Port Renewed Stitching on Ribs

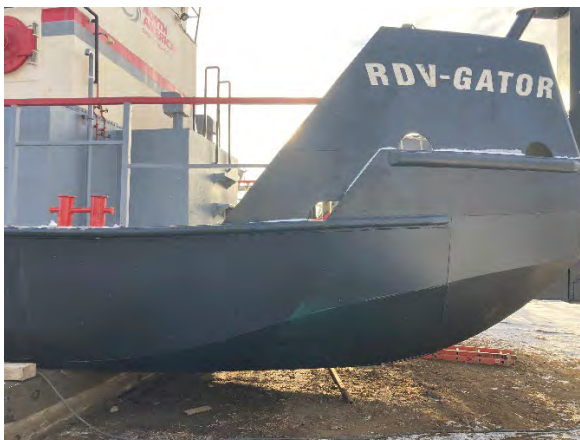
ITEM #3 Starboard Side Renewed

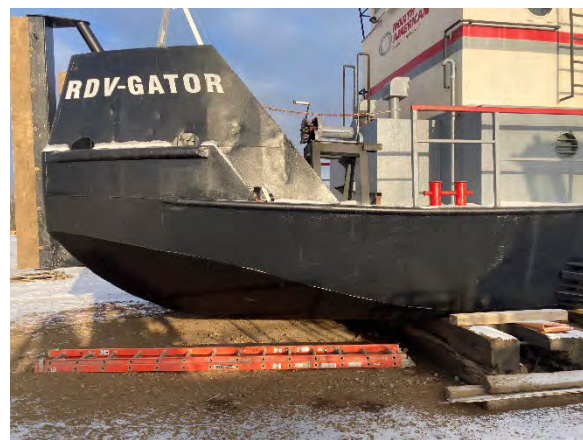
1ITEM #3 Port Side Renewed

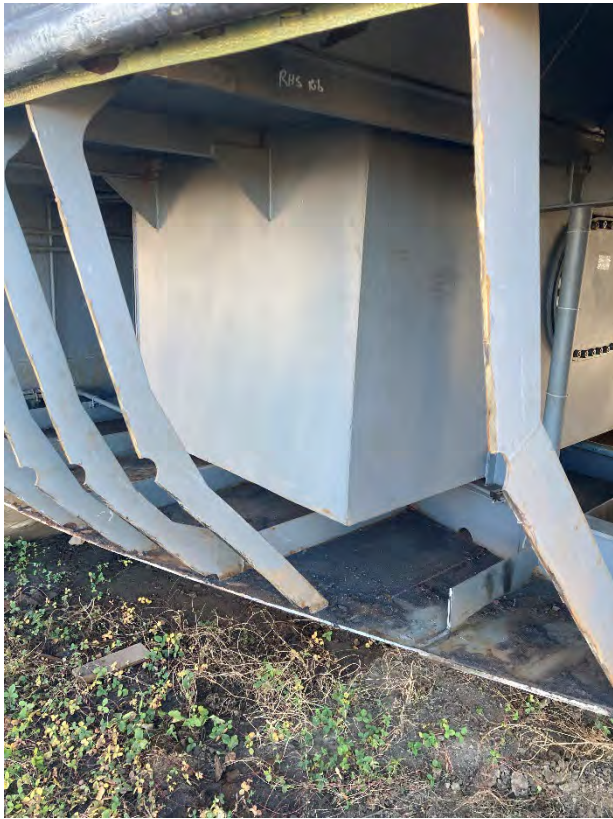
ITEM #4 Starboard Side Frame #20 Cropped

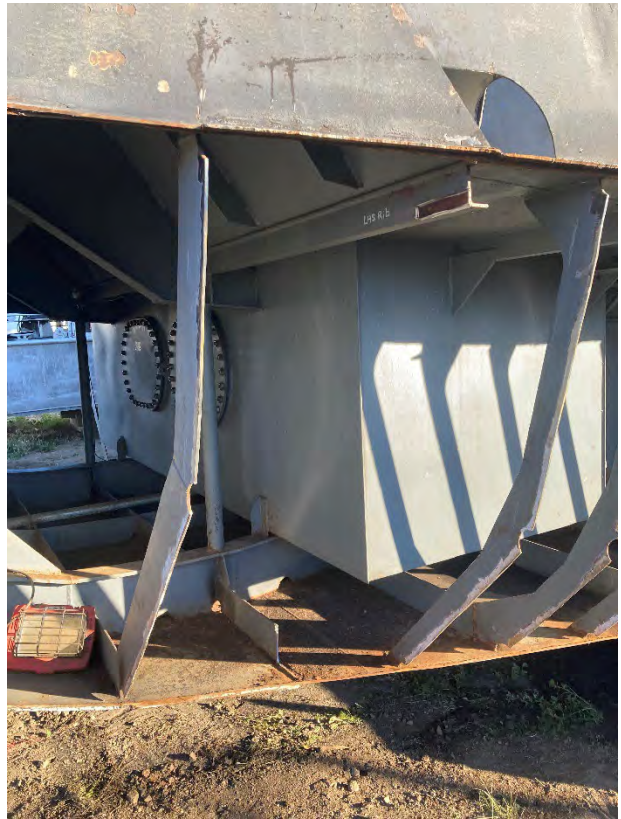
ITEM #4 Port Side Frame #20 Cropped

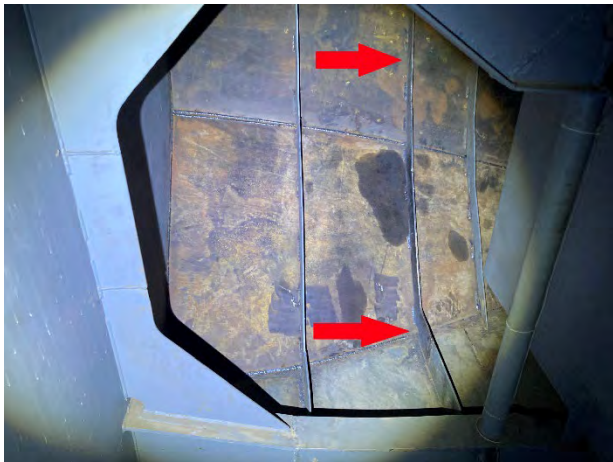
ITEM #4 Starboard Frame #20 Renewed

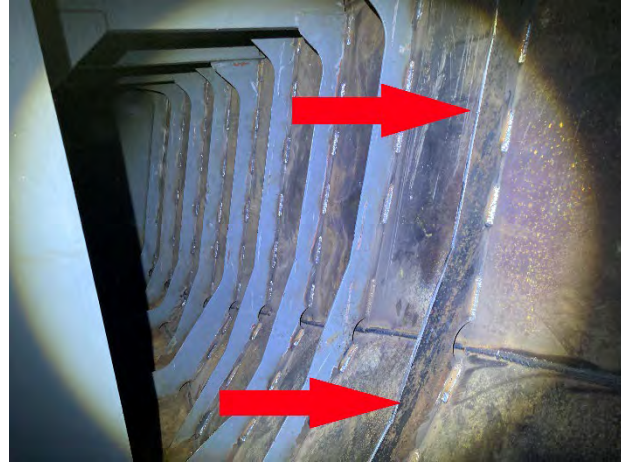
ITEM #4 Port Frame #20 Renewed

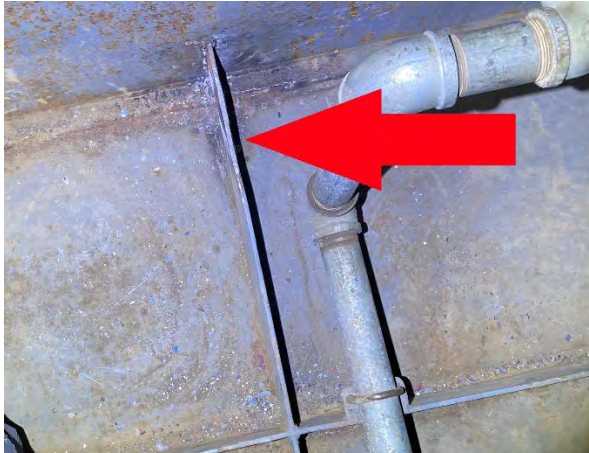
ITEM #5 Keel Straightened

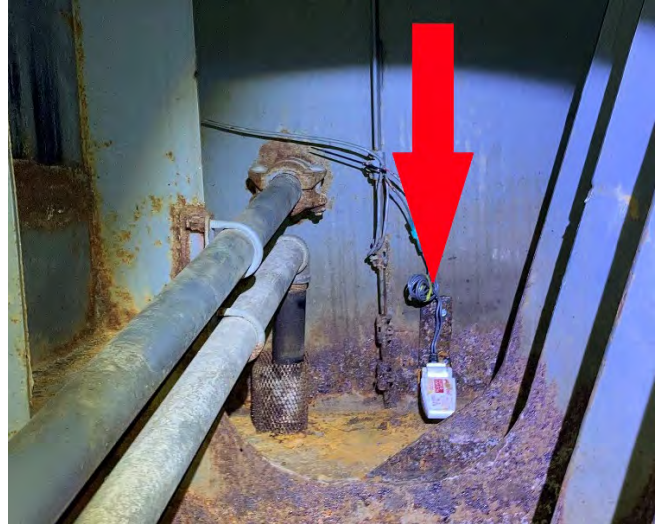
ITEM #6 Void Space #3 High water Sensor Secured

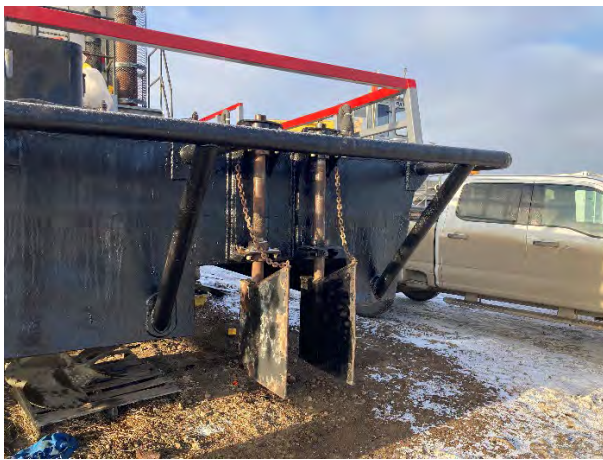
ITEM #7 Starboard Rudder Supports Renewed

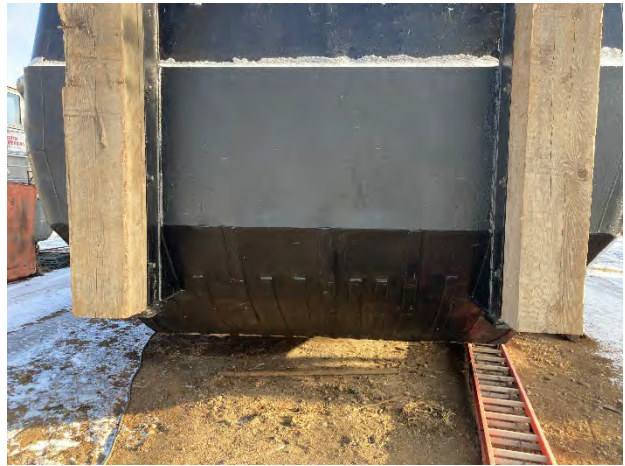
ITEM #8 Doubler Plates Removed

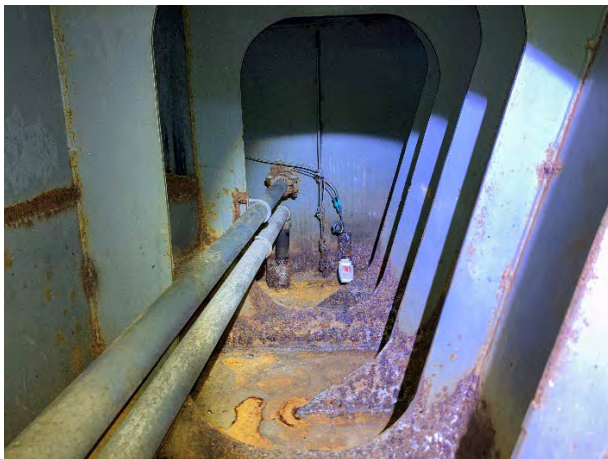
ITEM #9 Void space #3 Water and Sludge Cleaned

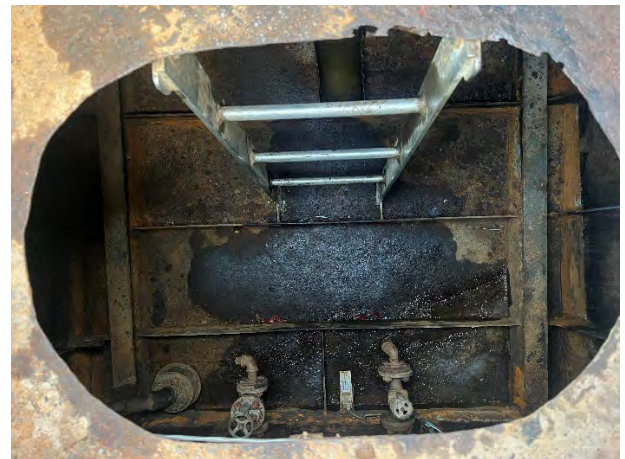
ITEM #10 Lazarette Sludge Cleaned

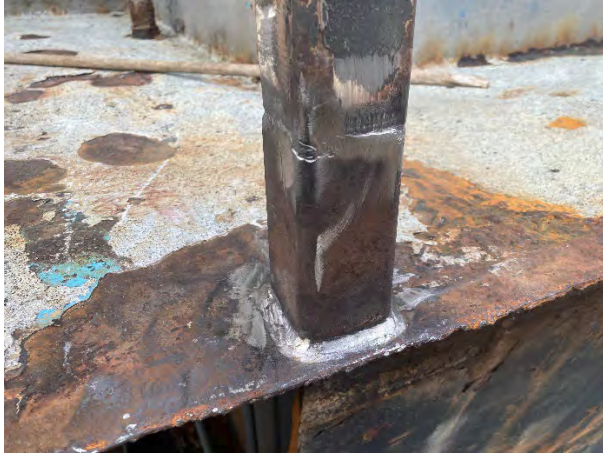
ITEM #12 Cropped Handrails Renewed

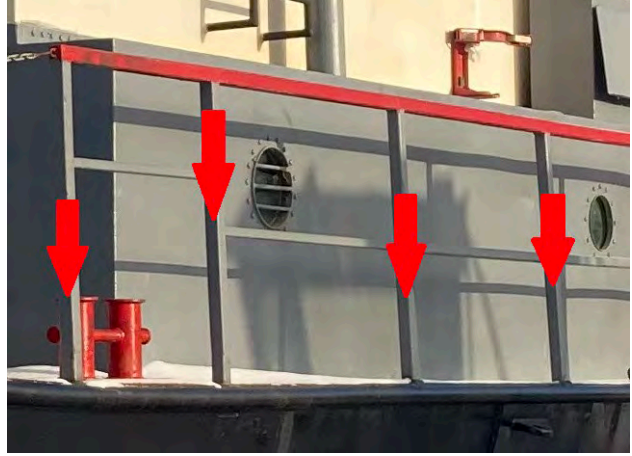
ITEM #12 Handrails Cropped and Renewed

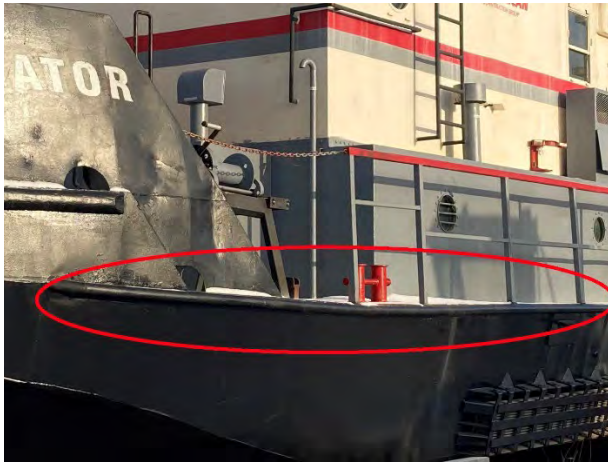
ITEM #13 Rub Rail Cropped and Renewed

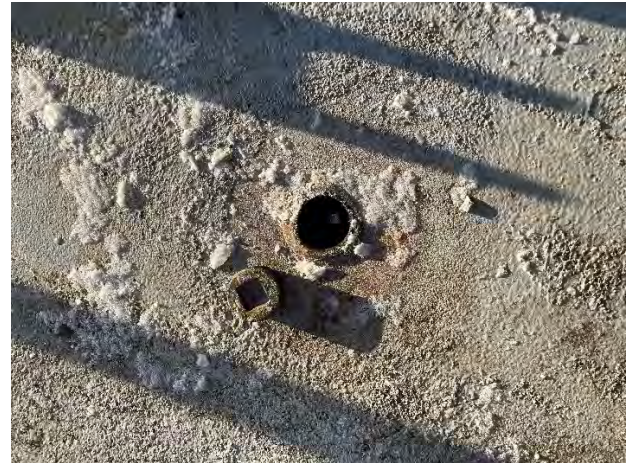
ITEM #16 Fuel Shut off Valves Made Functional

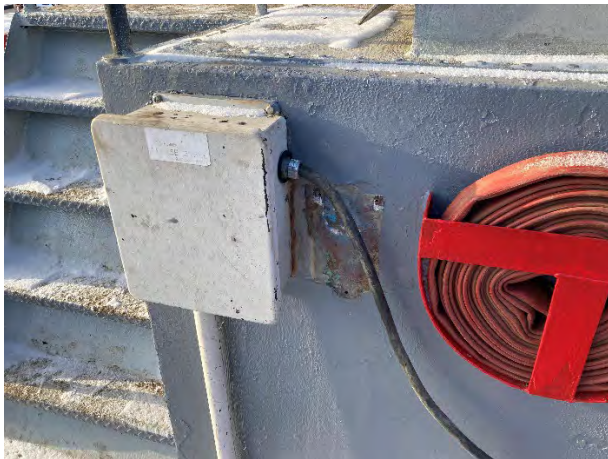
ITEM #19 Shore Power Cable Repaired

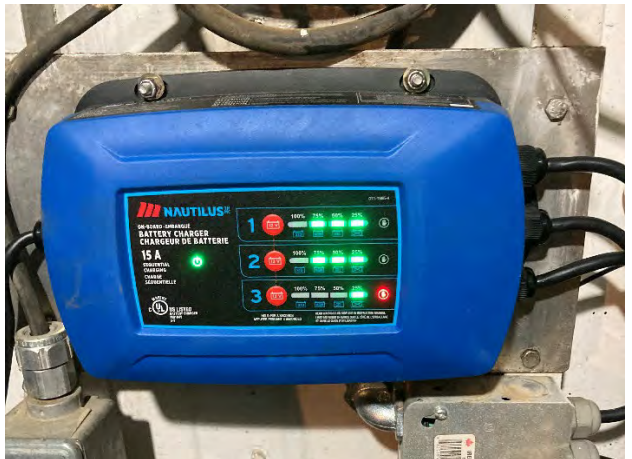
ITEM #31 House Battery Charger Replaced

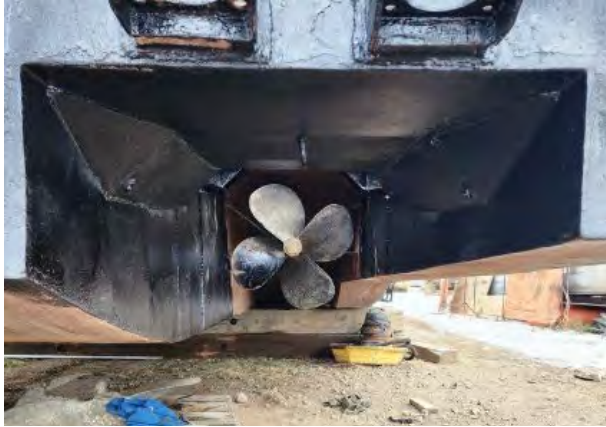
ITEM #32/33 Shafts and Props Installed Starboard

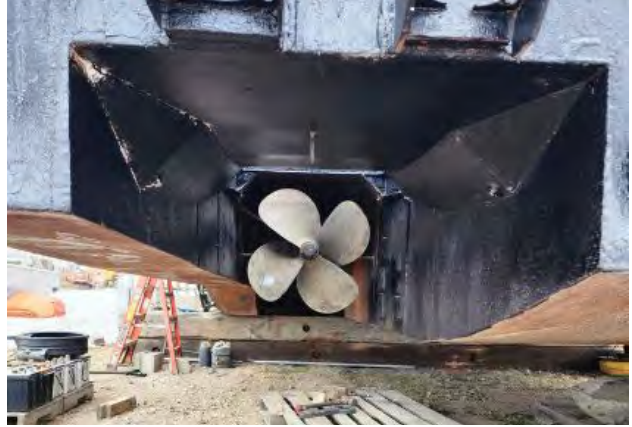
ITEM #32/33 Shafts and Props Installed Port

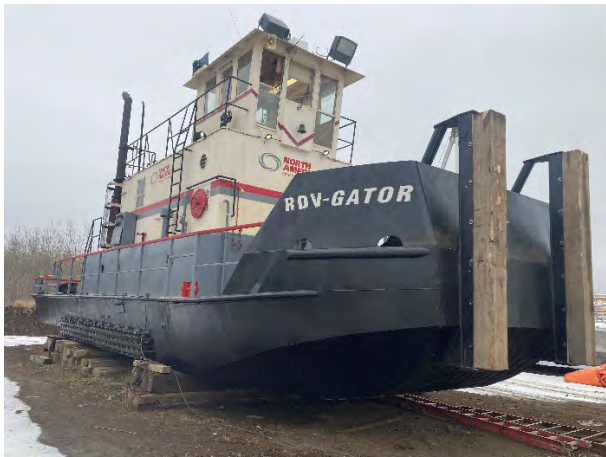
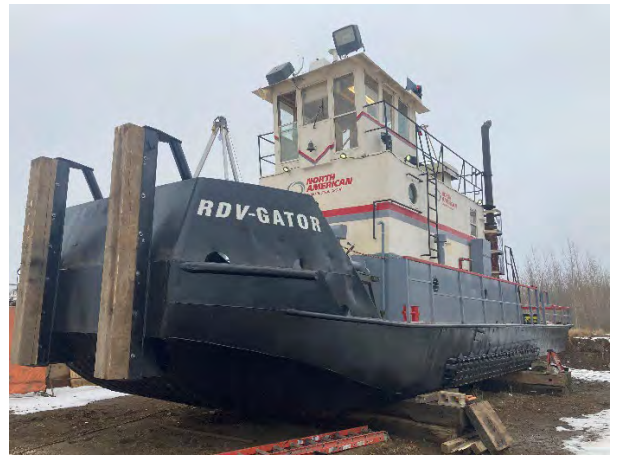
ITEM #34 Much of the vessel has been repainted top deck and hull using Carboguard 890 epoxy paint

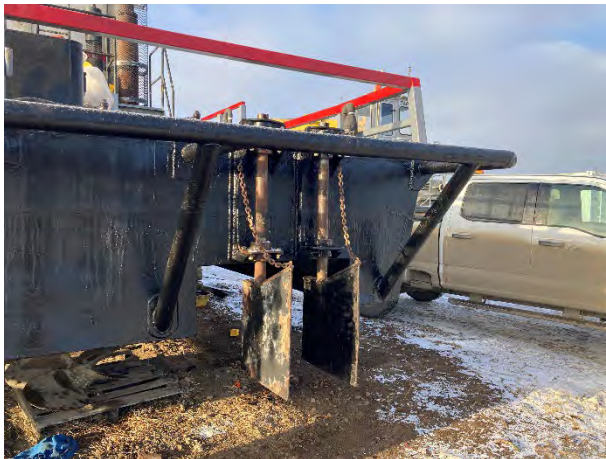
ITEM #35/36 Replaced Rudder Mounts and mounted Rudders

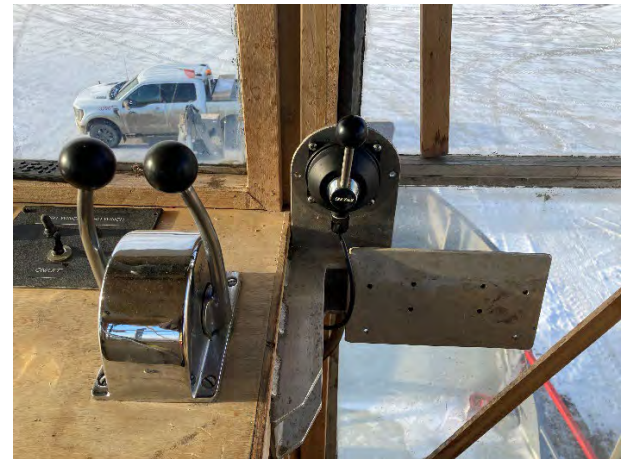
ITEM #37 Broken Jog Stick Replaced

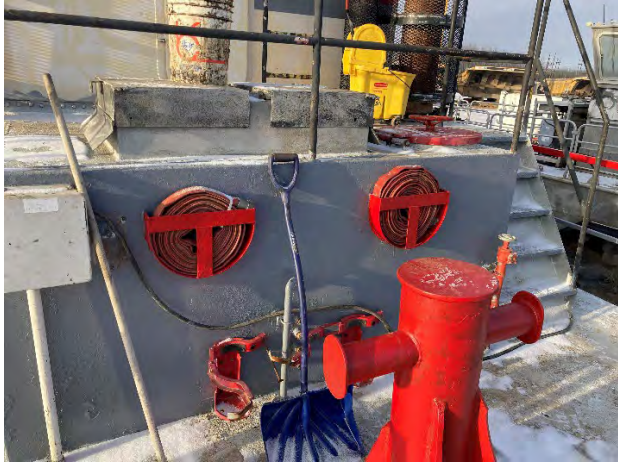
ITEM #38 Fire Hoses old and worn out replaced

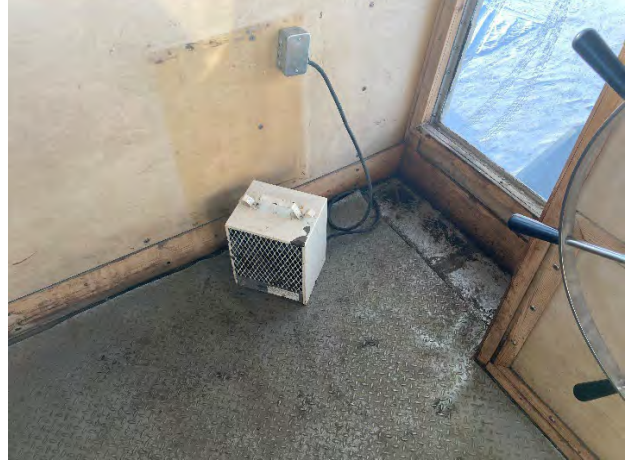
ITEM #39 Heater in Wheelhouse Replaced

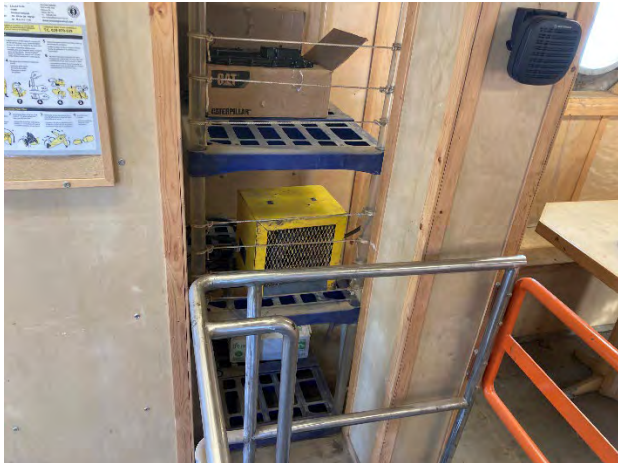
ITEM #40 Heater Installed in Galley

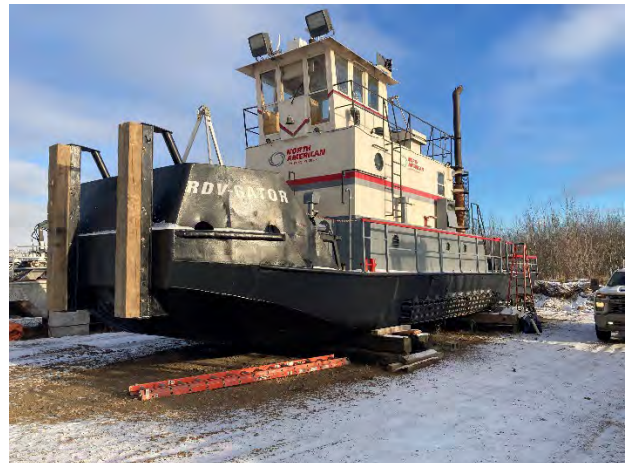
ITEM #41 Push Knees Replaced with new lumber
